DEPARTMENT OF TRANSPORTATION

Quality Assurance and Source Inspection

Contract #: 04-0120F4Cty: SF/ALA Rte: 80 PM: 13.2/13.9File #: 99.28**WELDING INSPECTION REPORT****Resident Engineer:**Siegenthaler, Peter**Address:** 333 Burma Road**City:** Oakland, CA 94607**Report No:** WIR-022555**Date Inspected:** 03-Apr-2011**Project Name:** SAS Superstructure**OSM Arrival Time:** 700**Prime Contractor:** American Bridge/Fluor Enterprises, a JV**OSM Departure Time:** 1900**Contractor:** Zhenhua Port Machinery Company, Ltd (ZPMC) Chanxing Island **Location:** Shanghai, China**CWI Name:** Mr. ZHU ZHONG HAI**CWI Present:** Yes No**Inspected CWI report:** Yes No N/A**Rod Oven in Use:** Yes No N/A**Electrode to specification:** Yes No N/A**Weld Procedures Followed:** Yes No N/A**Qualified Welders:** Yes No N/A**Verified Joint Fit-up:** Yes No N/A**Approved Drawings:** Yes No N/A**Approved WPS:** Yes No N/A**Delayed / Cancelled:** Yes No N/A**Bridge No:** 34-0006**Component:** OBG Segment**Summary of Items Observed:**

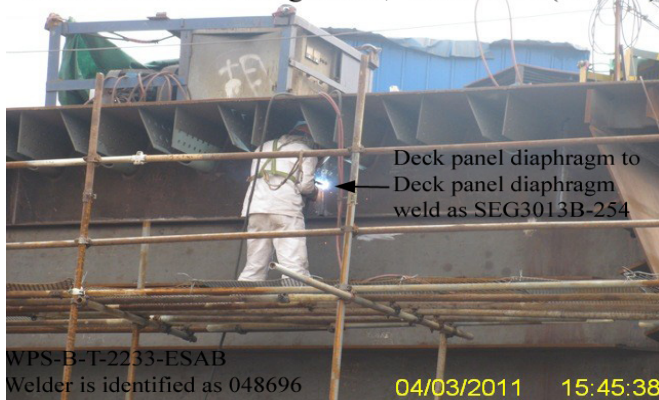
13AW at Counter weight side, Panel Point (PP-120)

ZPMC welding personnel performing Flux Core Arc Welding of Complete Joint Penetration welds joining the deck panel diaphragm to deck panel diaphragm weld joint located on 13AW at counter weight side, Panel Point (PP-120). The weld is designated as SEG3013B-254. The welder is identified as 048696. ZPMC QC Mr. SHEN JIAN BO was onsite monitoring the welding variables. The inprocess Flux Core Arc Welding appears to be progressing in compliance with WPS-B-T-2233-ESAB. Further weld detail mention in attached picture.

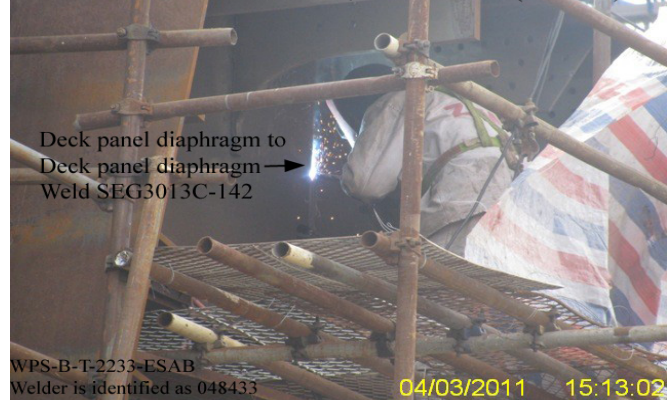
13AW at Cross Beam side, Panel Point (PP-120)

ZPMC welding personnel performing Flux Core Arc Welding of Complete Joint Penetration welds joining the deck panel diaphragm to deck panel diaphragm weld joint located on 13AW at cross beam side, Panel Point (PP-120). The weld is designated as SEG3013C-142. The welder is identified as 048433. ZPMC QC Mr. SHEN

JIAN BO was onsite monitoring the welding variables. The inprocess Flux Core Arc Welding appears to be progressing in compliance with WPS-B-T-2233-ESAB. Further weld detail mention in attached picture.
